Report of  
Dam Safety Assessment of Coal Combustion  
Surface Impoundments

Kentucky Utilities,  
a wholly owned subsidiary of LG&E and KU Energy LLC

Pineville Generating Station, Pineville, KY

AMEC Project No. 3-2106-0177.0003

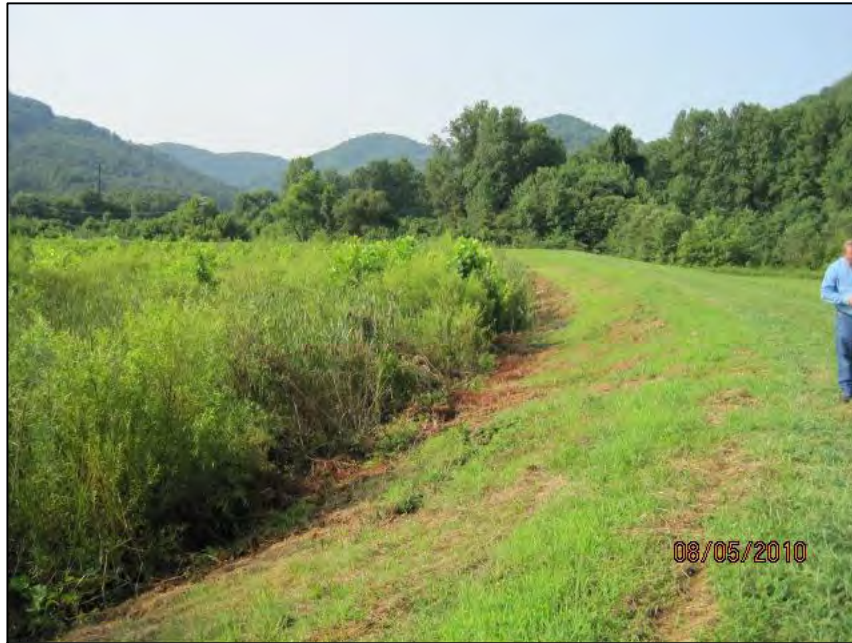
**1-1**

**SOUTHWEST INTERIOR SLOPE AND CREST**

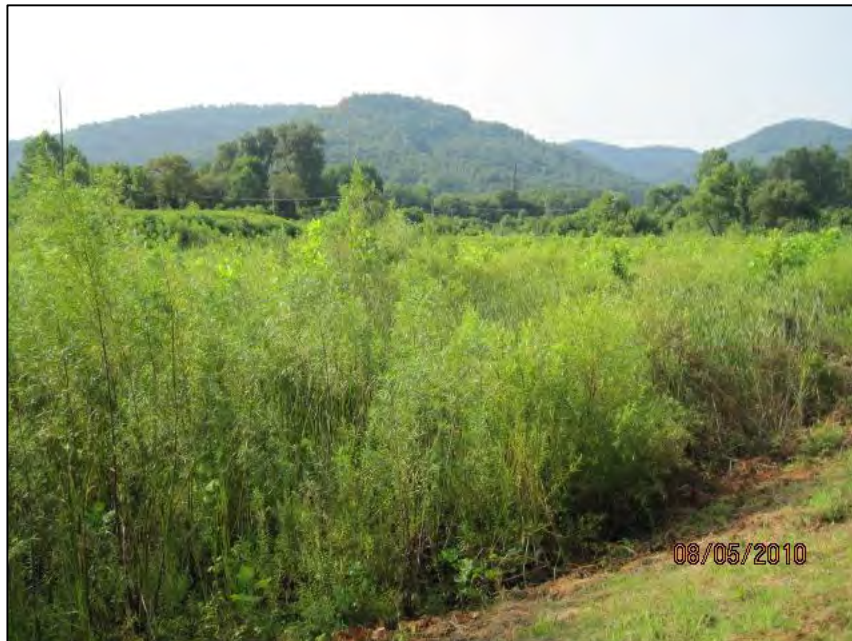
**1-2**

**FROM SOUTHWEST DIKE LOOKING SOUTHEAST AT POND INTERIOR**

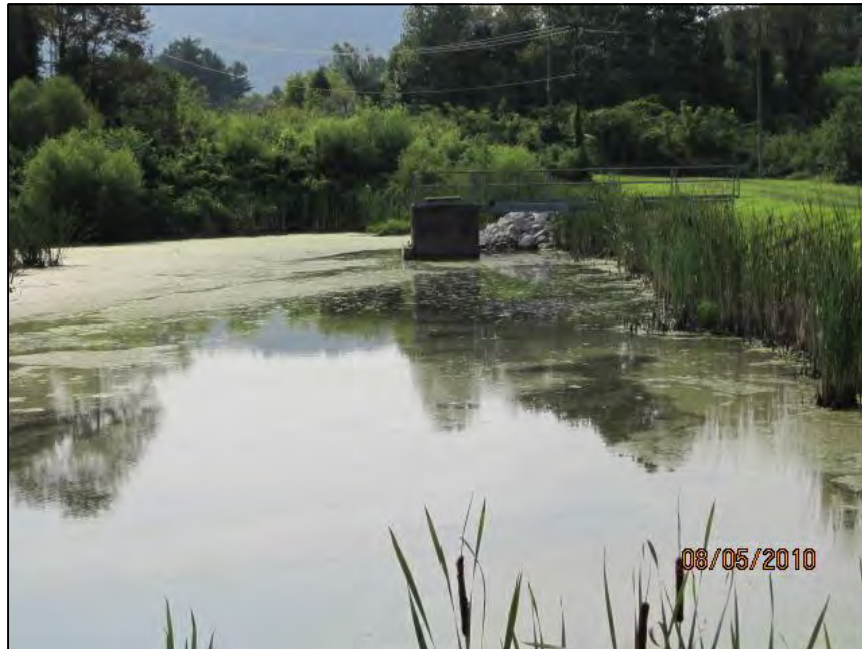
**1-3**

**FROM SOUTHWEST DIKE LOOKING EAST TOWARDS OUTLET STRUCTURE**

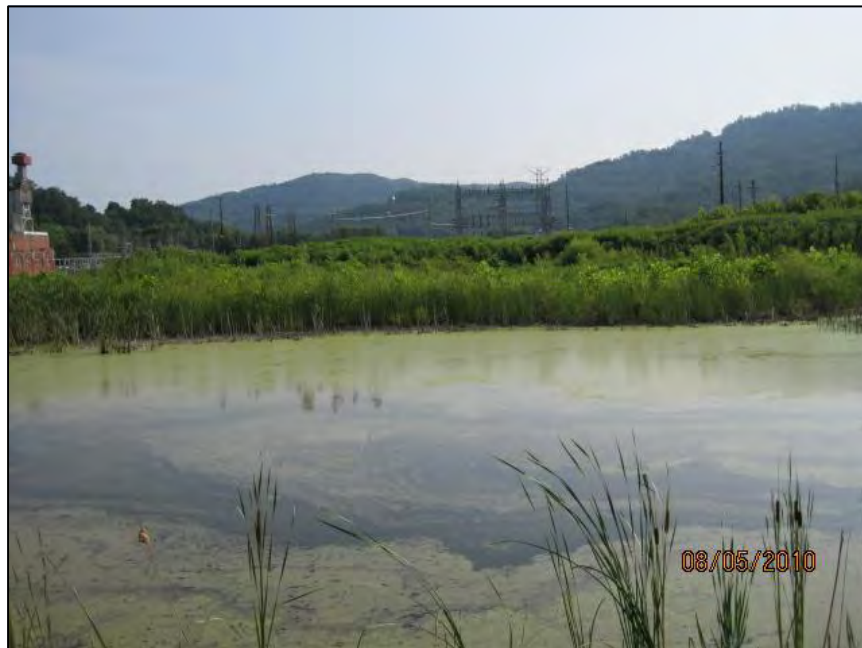
**1-4**

**FROM SOUTH DIKE LOOKING NORTH TOWARDS SUBSTATION**

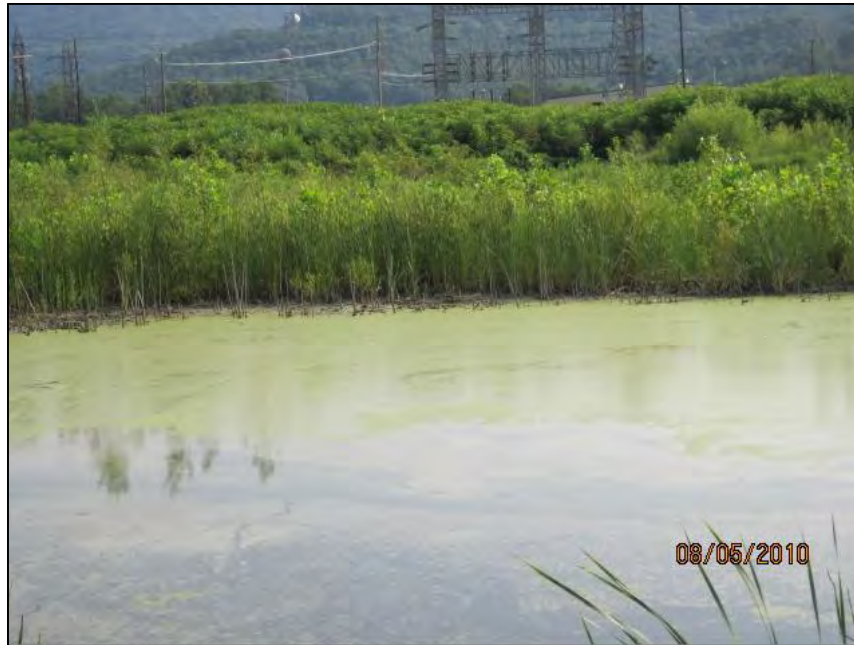
**1-5**

**FROM SOUTH DIKE LOOKING EAST TOWARDS SUBSTATION**

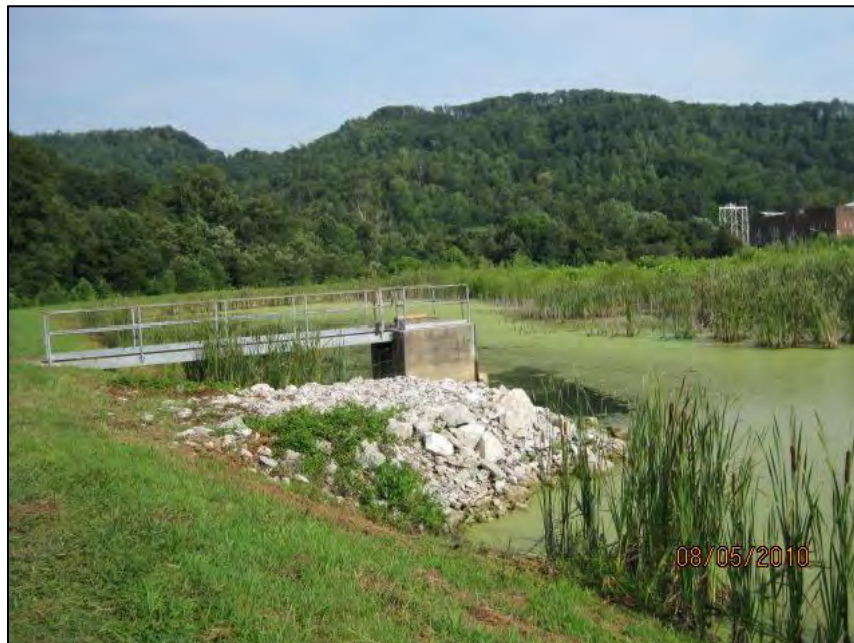
**1-6**

**FROM EAST END OF SOUTH DIKE LOOKING NORTHWEST TOWARDS OUTLET STRUCTURE**

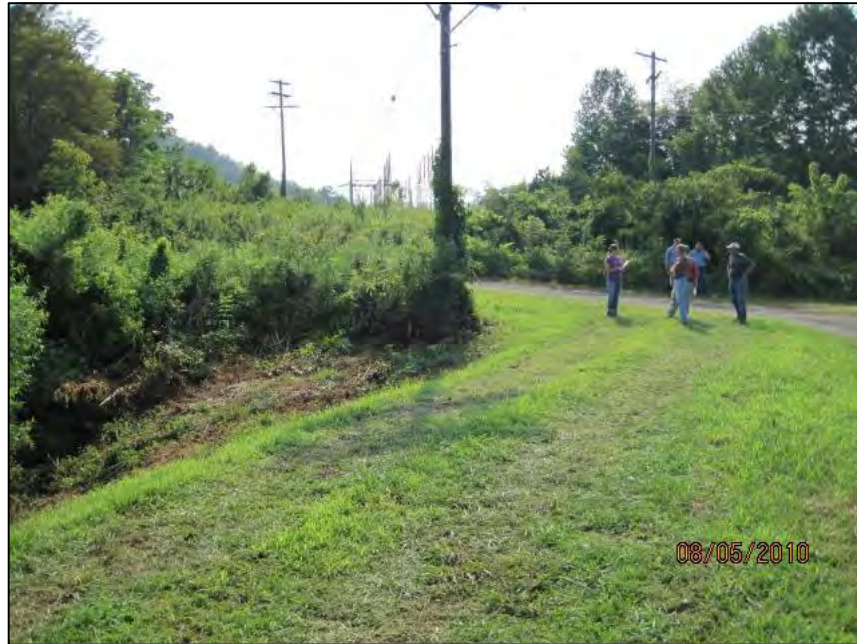
**1-7**

**LOOKING EAST AT TIE-IN TO ORIGINAL GROUND AT SOUTHEAST CORNER**

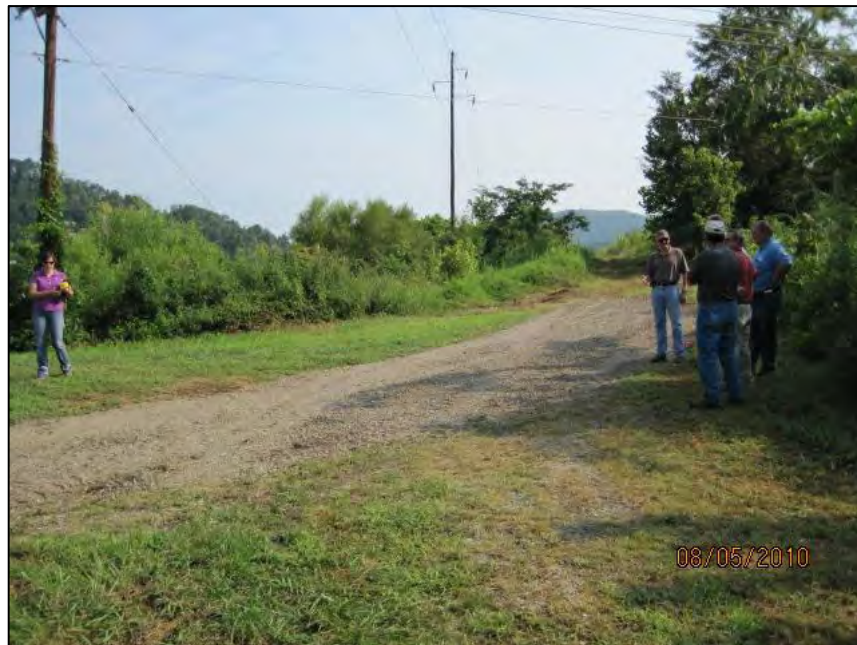
**1-8**

**LOOKING NORTH AT SOUTHEAST CORNER**

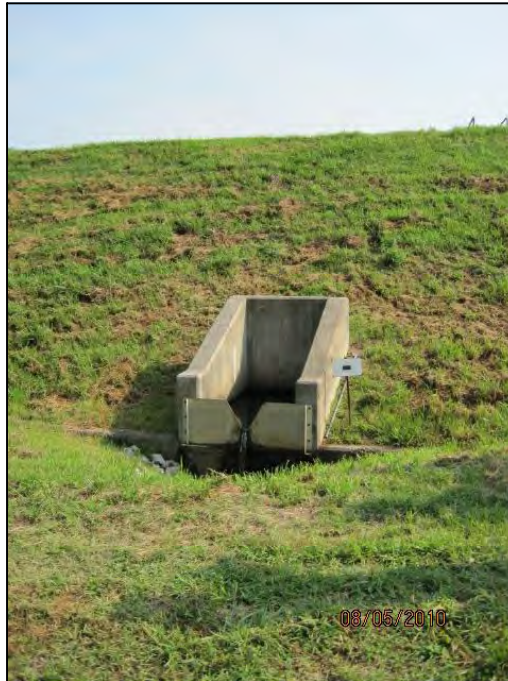
**1-9**

**POND OUTLET AND KPDES OUTFALL 001 AT TOE OF SOUTH DIKE**

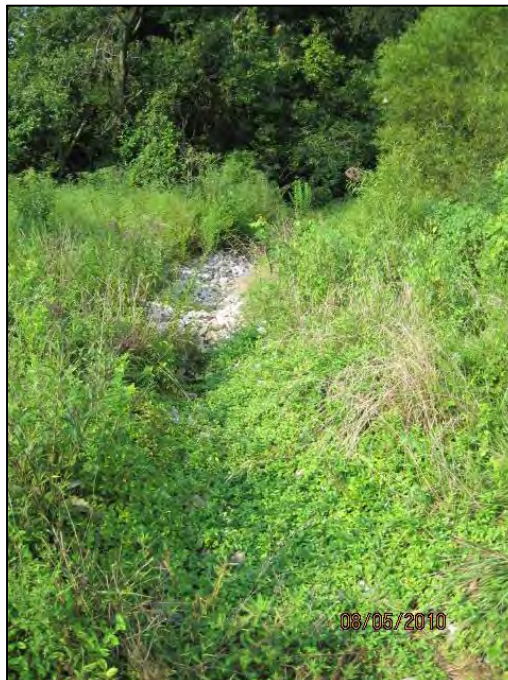
**1-10**

**LOOKING SOUTH AT DRAINAGE CHANNEL FROM OUTFALL TO CUMBERLAND RIVER**

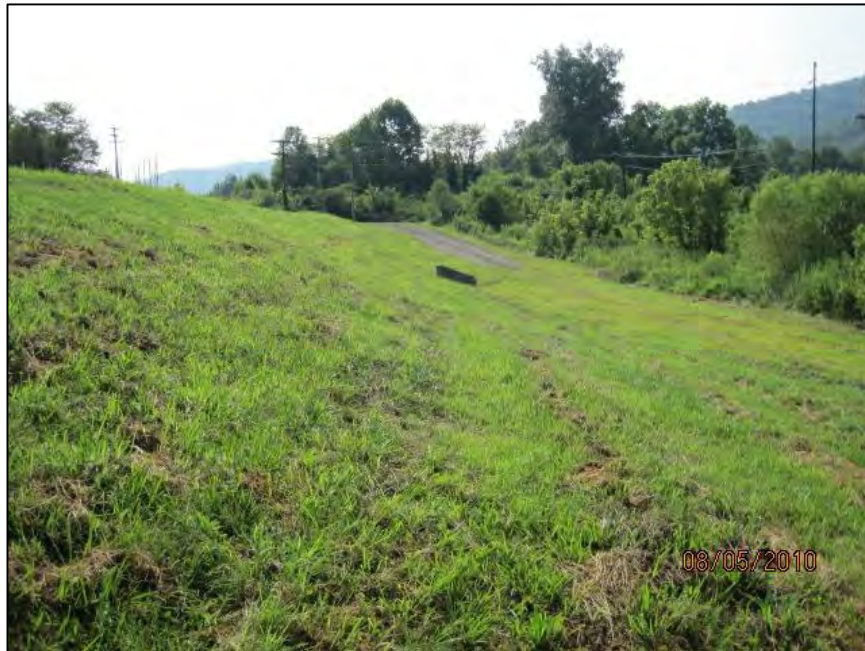
**1-11**

The Ash Pond has a side-hill configuration consisting of two constructed embankments along the south and west pond limits. A freeboard of approximately 6 feet between the top of ash and top of dike was observed during the site visit (photos 1-1 and 1-6). The crest and dikes (upstream and downstream) of the dam are primarily surfaced with grass (photos 1-1, 1-7, and 1-11 through 1-14). Vegetation was observed along the pond interior at the north and central sections of the pond (photos 1-1, 1-2, 1-4, 1-14 and 1-15). Vegetation along the interior slopes of the south end of the pond was noticeably less dense (photo 1-6). KU personnel reported they had used farm machinery on the higher central and north sections of the pond in 2009 to cut the vegetation. Two small repaired animal burrow areas were observed on the upstream slope of the south dike (photo 1-6). Uneven slopes were observed on the downstream slopes from the west half of the south dike extending around the southwest corner to the south end of the west dike (photos 1-11 and 1-12).

**LOOKING EAST AT SOUTH DIKE DOWNSTREAM SLOPE**

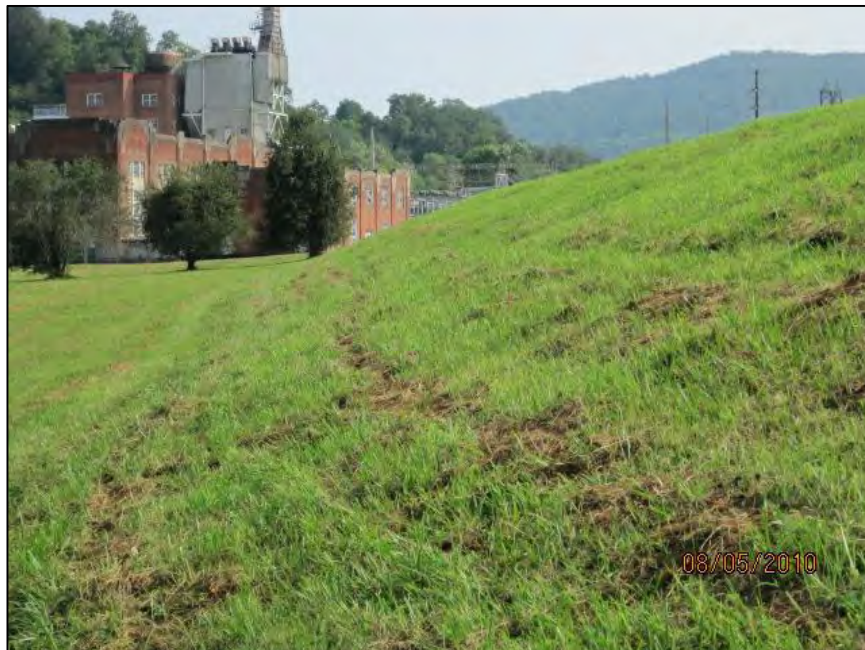
**1-12**

**LOOKING NORTH AT SOUTHWEST DOWNSTREAM SLOPE**

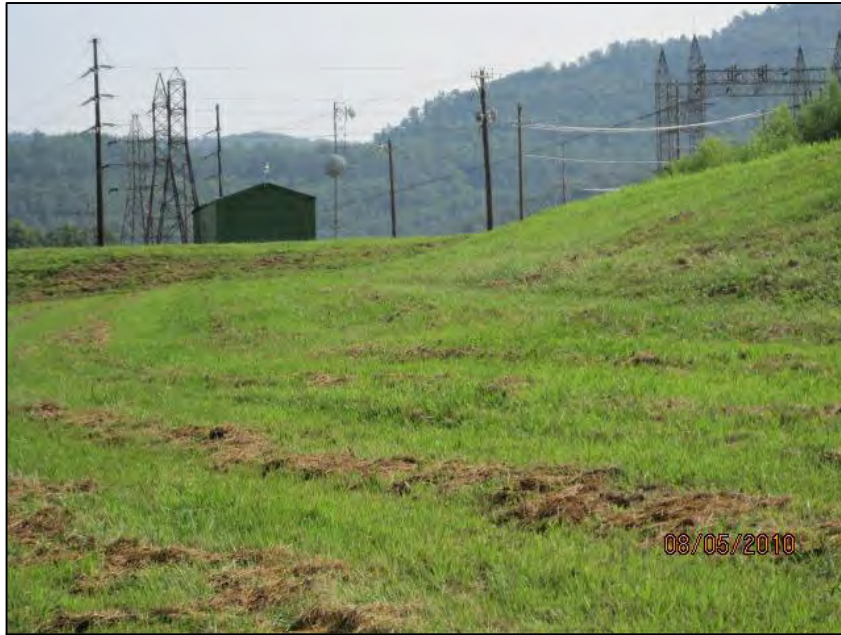
**1-13**

**LOOKING NORTHEAST AT UPPER SECTION OF WEST DIKE, TIE-IN TO ORIGINAL GROUND**

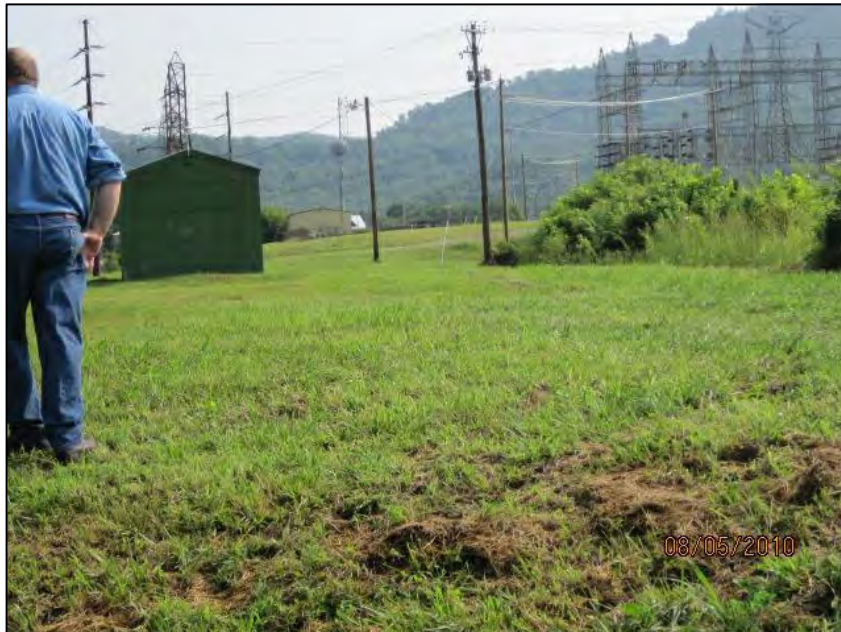
**1-14**

**LOOKING NORTHEAST AT WEST CORNER OF NORTH SIDE OF POND**

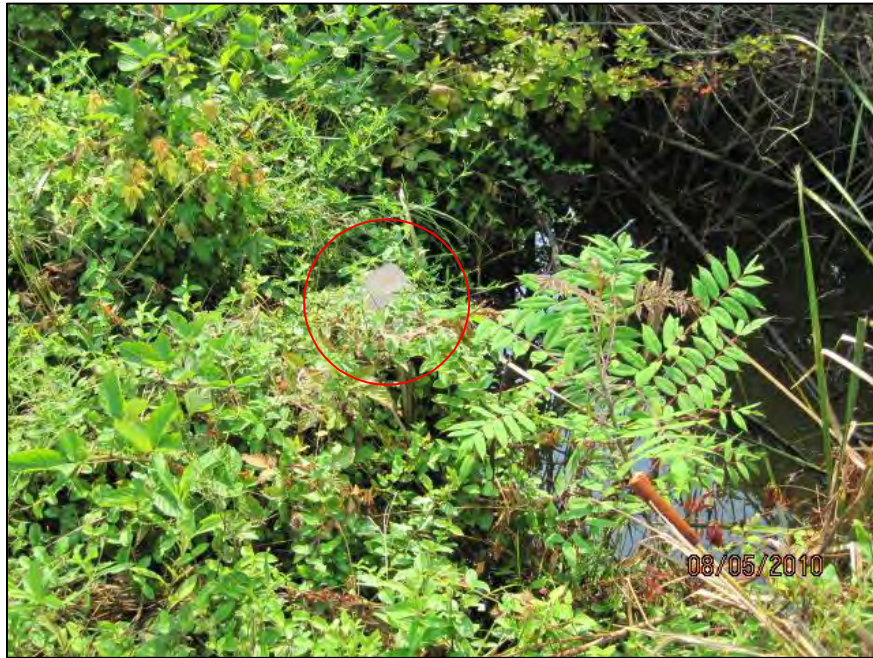
**1-15**

**POND INLET NEAR WEST CORNER OF NORTH SIDE OF POND**
